AVIATION INVESTIGATION REPORT

A01P0305

AIRCRAFT MISIDENTIFICATION—SAFETY NOT ASSURED

11 DECEMBER 2001

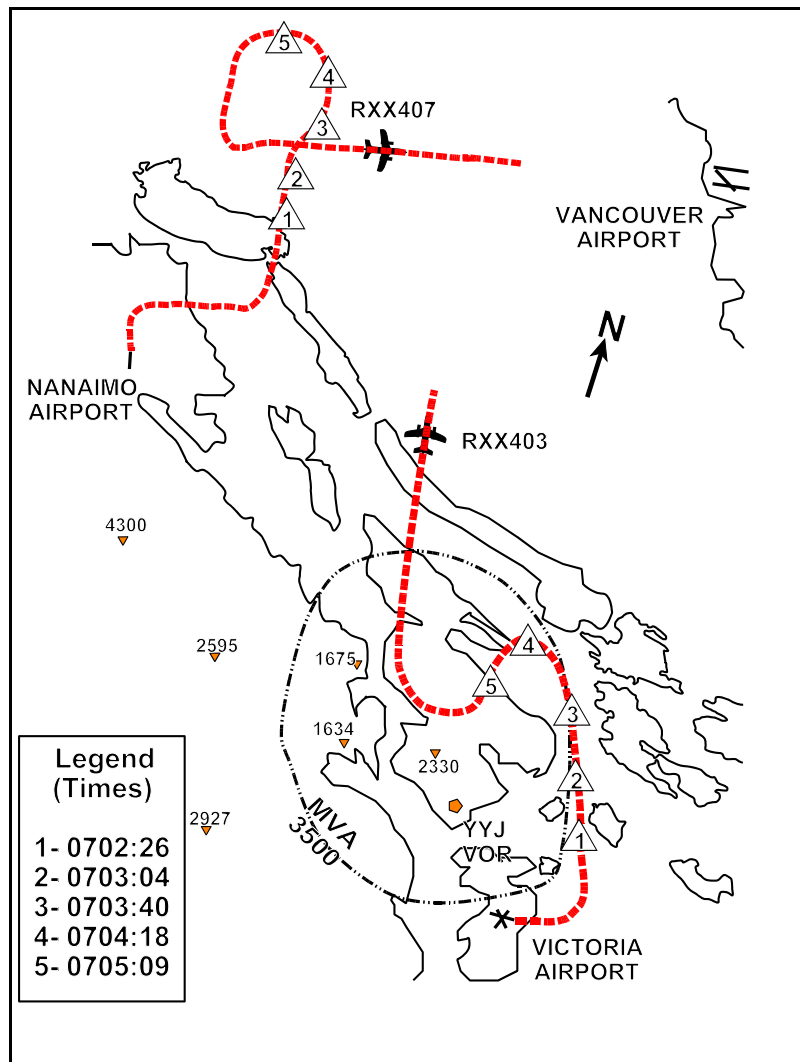
Figure 1. Flight paths for RXX403 and RXX407

Errors with aircraft identification made by both pilot and controller in this readback/hearback process led to the controller issuing instructions intended for RXX407 to the wrong aircraft, namely RXX403, resulting in RXX403 flying into a 3500-foot MVA at 3000 feet.
